CYCLE TESTING OF ACS VALVES IN CLF₅ FINAL REPORT

TECHNICAL REPORT AFRPL-TR-72-82

AUGUST 1972

AIR FORCE ROCKET PROPULSION LABORATORY

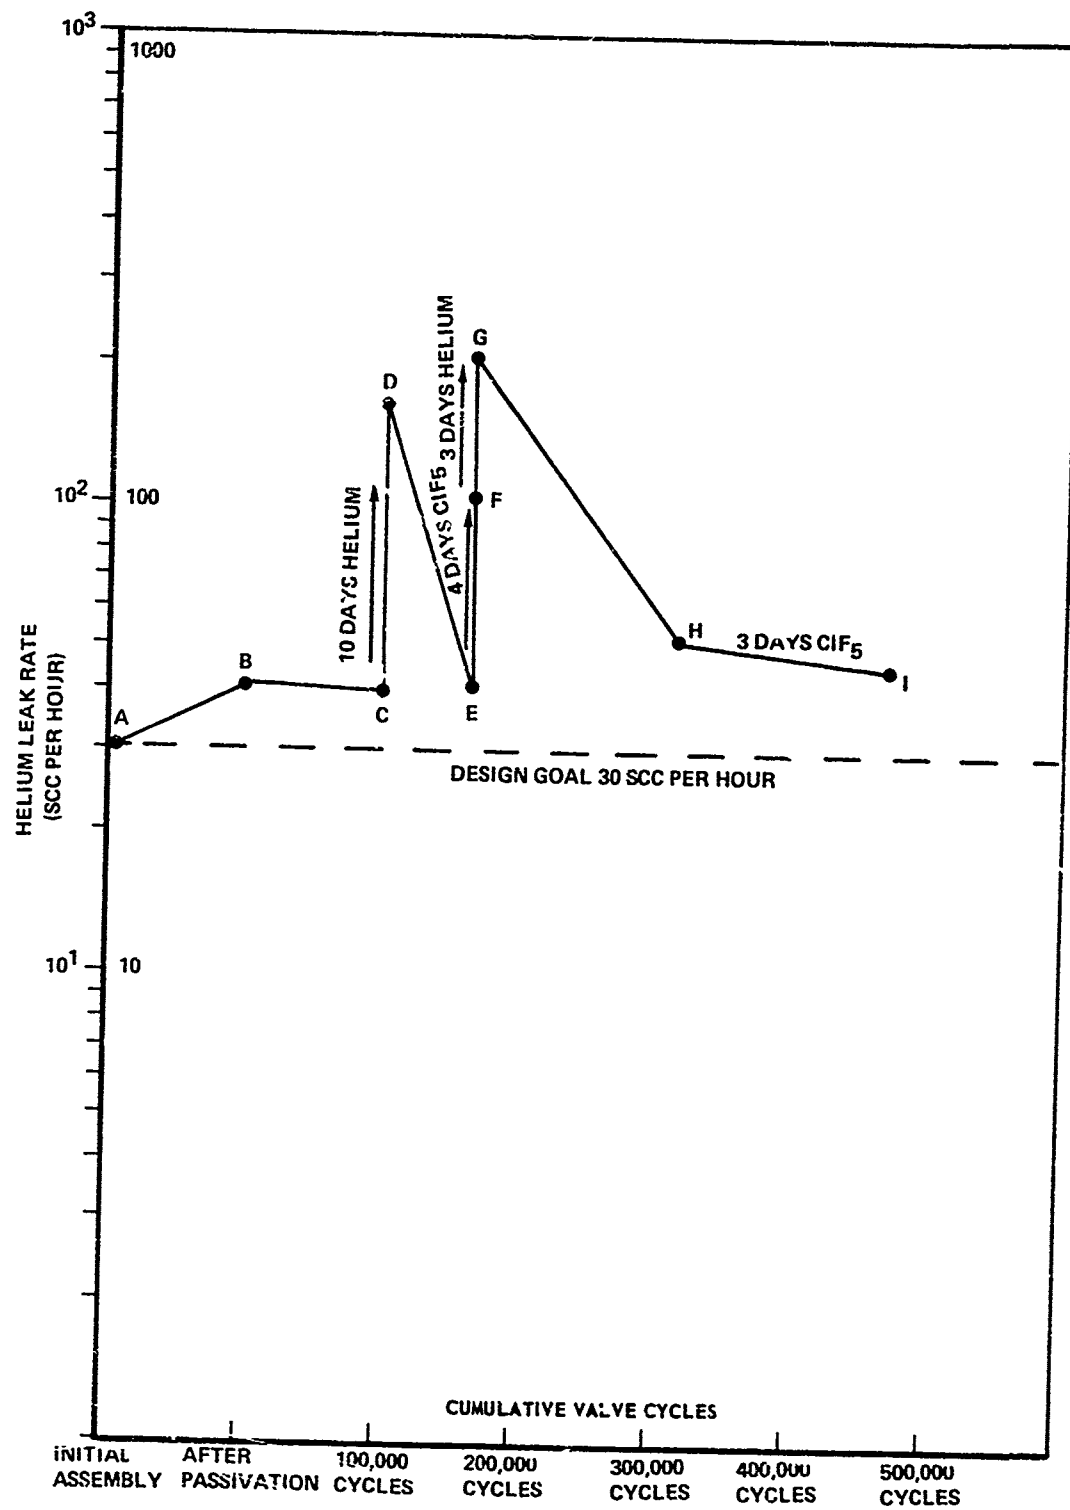
Figure 11. Leakage versus Valve Cycles, Test No. 14.

This test encompassed a 23-day period during which 10 days of ClF_5 exposure and 470,000 cycles were accumulated. Figure 11 depicts the leakage characteristics of the valve throughout the test.

Upon initial assembly, the valve leaked 30 scc helium per hour (Point A), and the leakage increased to 41 scc/hour (Point B) upon GF_2 passivation. During the first day's testing in ClF_5 , approximately 100,000 cycles were accumulated, resulting in a leak rate of 40 scc/hour (Point C). The valve was then left pressurized with helium for a 10-day period. For some reason, the leak rate measured at the end of this 10-day period increased to over 150 scc/hour (Point D). Cycling in ClF_5 was begun and an additional 63,000 actuations were accumulated. Leakage returned to a level of about 40 scc/hour after this day's test (Point E).

The valve was then exposed to ambient temperature ClF_5 (Reference 1) at the normal vapor pressure for a period of 4 days. Again, without further cycling of the valve in ClF_5 , the leakage increased, this time to about 100 scc/hour (Point E). The lines were drained and the valve purged, dried and pressurized with helium. After a 3-day exposure to the helium, leakage measured slightly over 200 scc/hour (Point G), and cycling in ClF_5 was begun again. As had happened before, after an additional

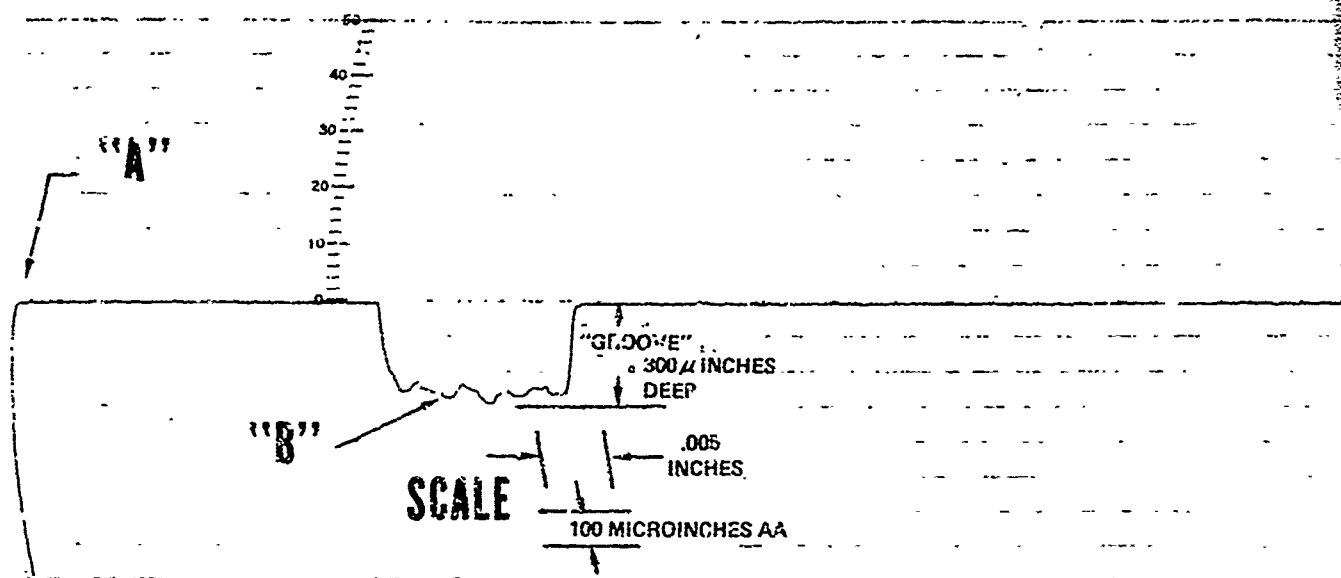
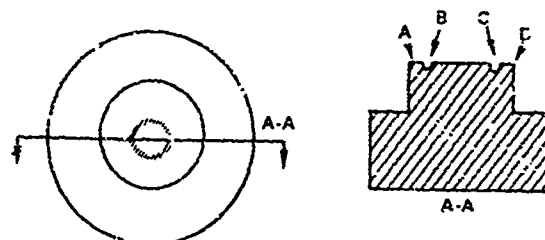
Figure 14. Proficorder Trace, K-96 Poppet, Post-Test 14.

WORN AREA ON POPPET FACE
WHERE SEAT CONTACT IS MADE

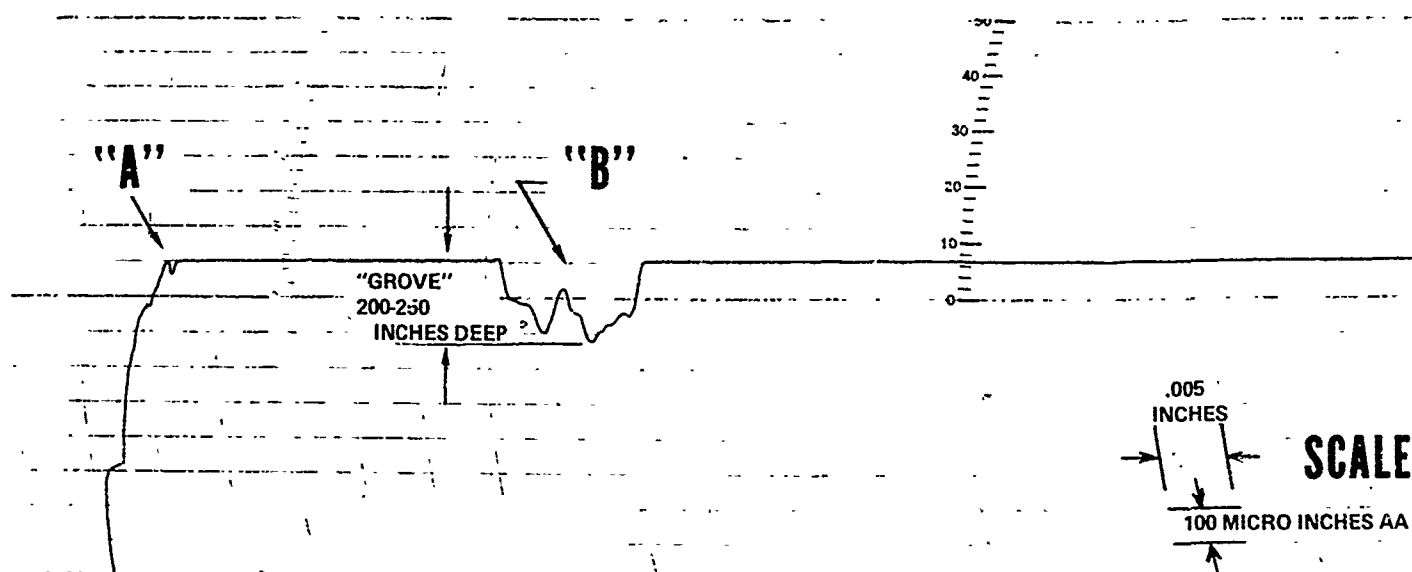
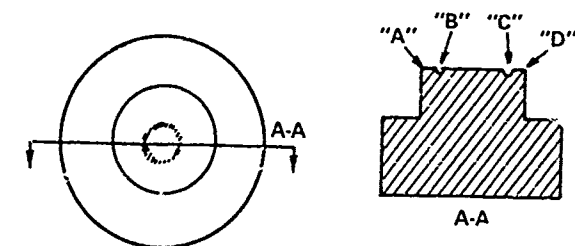
Figure 46. Proficorder Trace, Aluminum on Ni 301 Poppet,
Post ClF₅ Testing

WORN AREA ON POPPET FACE
WHERE SEAT CONTACT IS MADE
